Final
Five-Year ROD Review Report
First Five-Year Review Report for
Allegany Ballistic Laboratory
Superfund Site
Rocket Center, West Virginia

**Final
Five-Year ROD Review Report**

**Allegany Ballistics Laboratory Superfund Site
Rocket Center, West Virginia**

June 2002

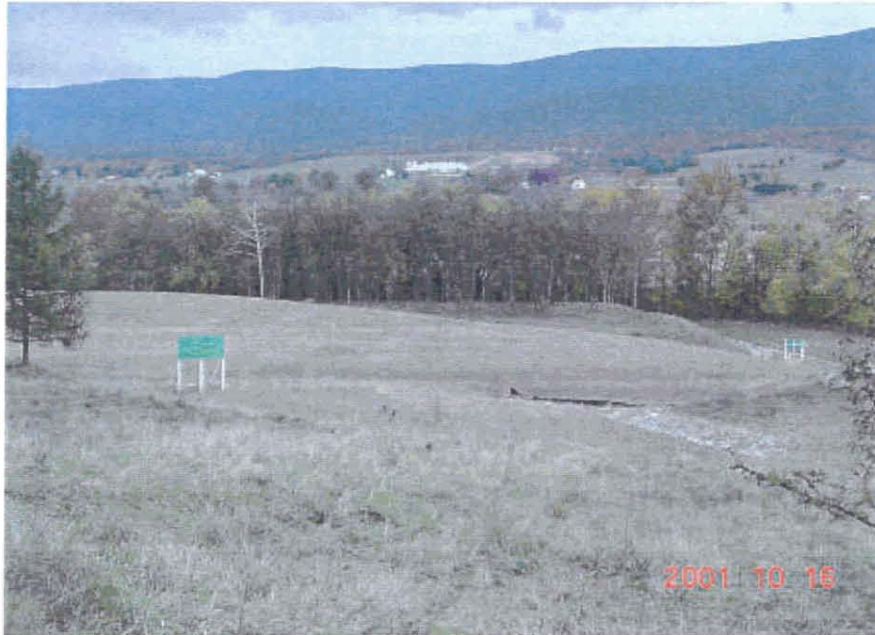
Photograph No.: 1
Date: October 16, 2001

Description: Site 5 Landfill Cap showing the locations of two of the landfill perimeter access restriction signs. Note the segment of the perimeter rip-rap surface-water drainage channel in the foreground.

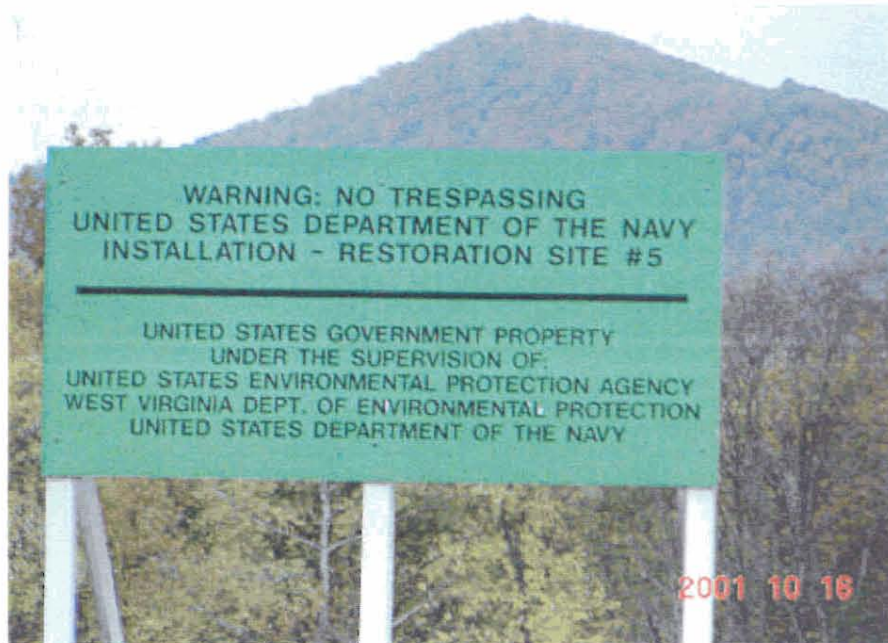
Photograph No.: 2
Date: October 16, 2001

Description: Close-up of a Site 5 landfill access restriction sign.

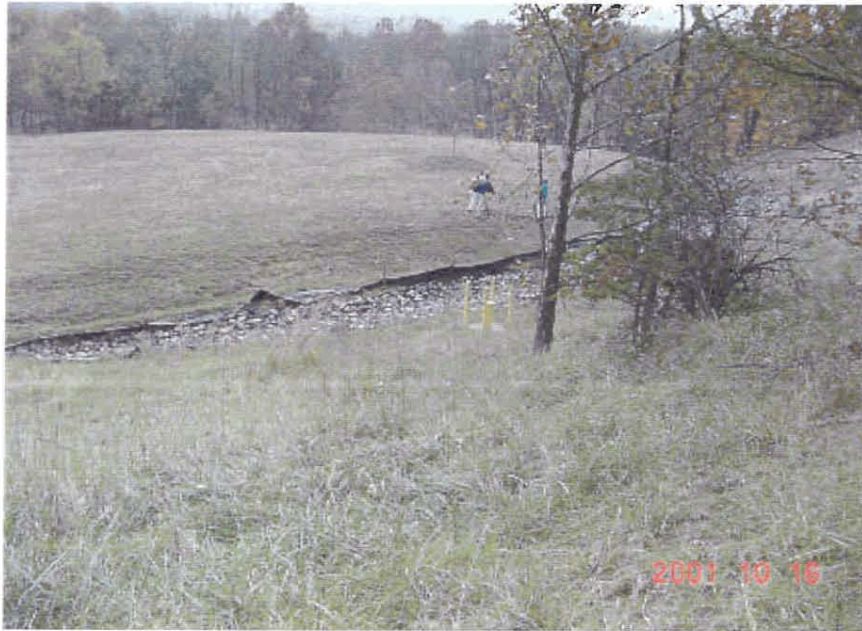
Photograph No.: 3
Date: October 16, 2001

Description: Site 5 landfill cap from adjacent embankment. Note the perimeter drainage channel and landfill gas monitoring well 5LGMW01 in the foreground.

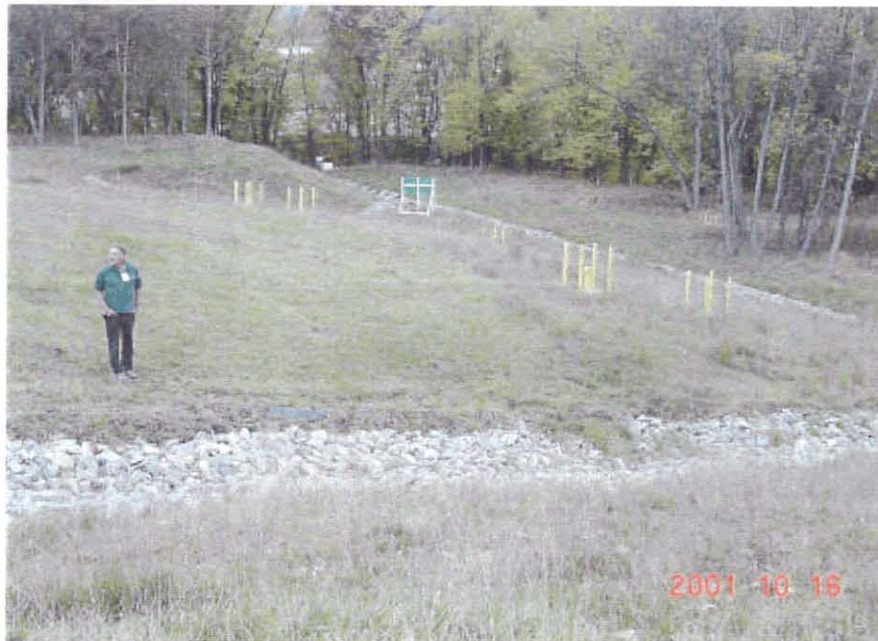
Photograph No.: 4
Date: October 16, 2001

Description: Western edge of Site 5 landfill cap. Note perimeter drainage channel and several groundwater monitoring wells.

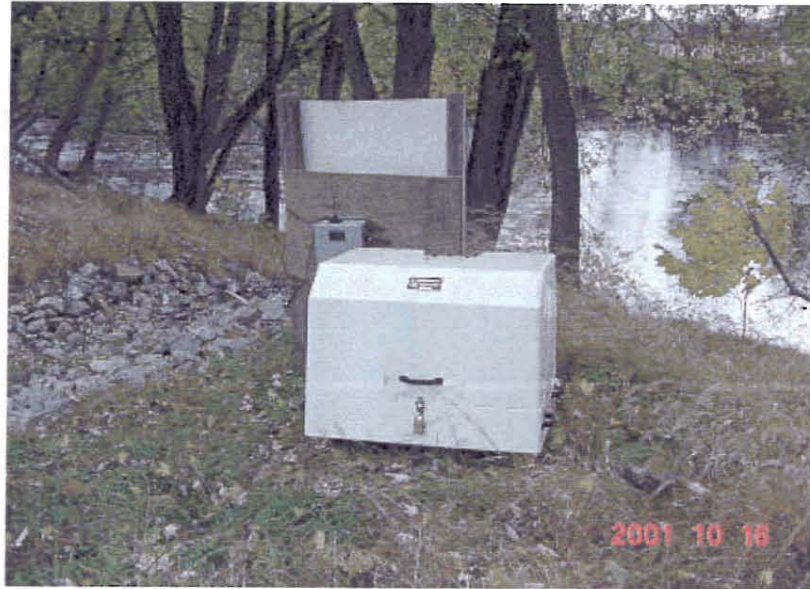
Photograph No.: 5

Description: Close-up of the stormwater runoff autosampler at the perimeter drainage channel outfall to the North Branch Potomac River.

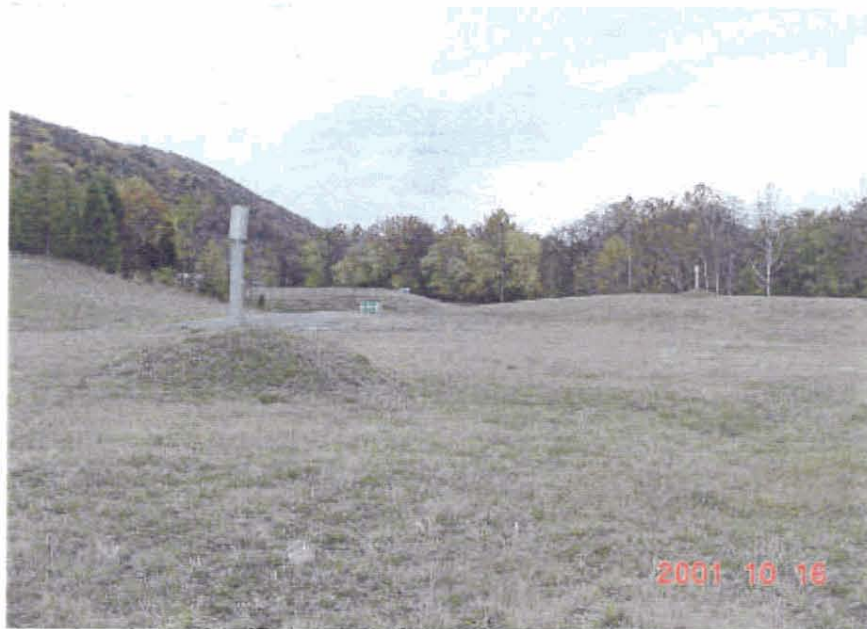
Photograph No.: 6

Description: General condition of the Site 5 landfill cap. Note the landfill gas vents in the background and foreground.

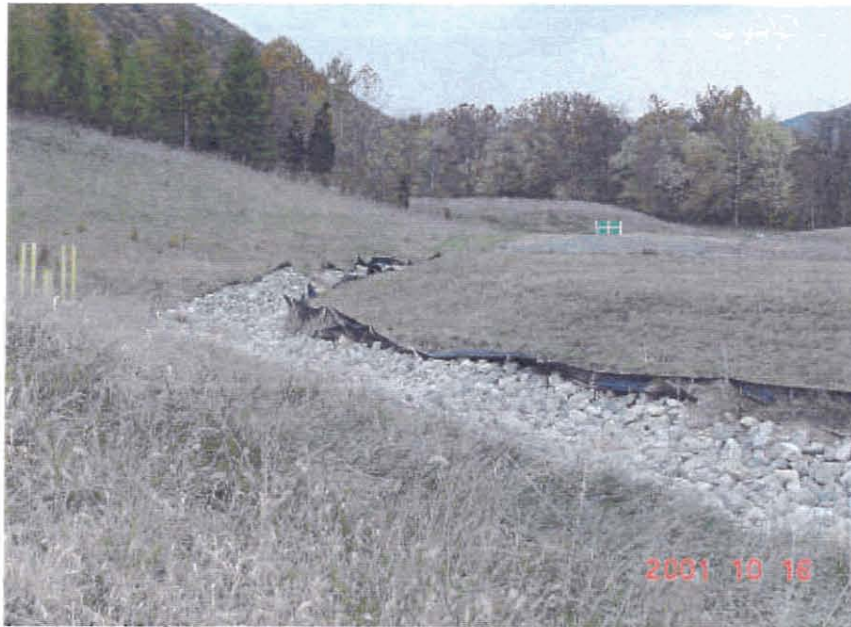
Photograph No.: 7

Description: General view showing eastern edge of the Site 5 landfill, a portion of the perimeter drainage channel, landfill gas monitoring well 5LGMW01, and the adjacent embankment.

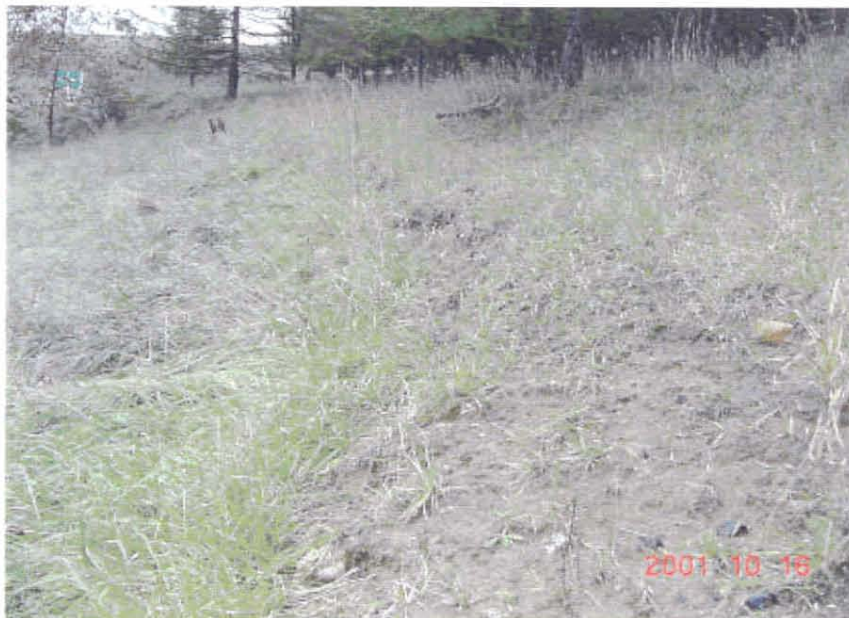
Photograph No.: 8

- ***System Operations/O&M:*** Operation and maintenance of the cap and drainage structures has, as a whole, been effective. During site inspections, slope creep has been observed on the hillside above Channel 4; however, this condition currently does not affect the performance or integrity of the cover system, but will continue to be monitored. Minor problems are corrected during the inspections, while more substantial repairs (e.g., access road repair) or modifications (e.g., installation of stormwater autosamplers) are first approved by the Navy.

Description: Close-up of the area of slope creep on embankment adjacent to east side of landfill.

- Prepare and implement a LUCIP for Site 5
- Monitor slope creep of the hillside above Drainage Channel 4 and make any necessary repairs
- Initiate and maintain a permanent compilation of all future repairs and corrective actions performed as part of O&M
- Update the Site 5 O&M and Long-Term Monitoring Plans to reflect current procedures
- Undertake a study to evaluate the extent of the methane gas and to determine whether corrective action is warranted

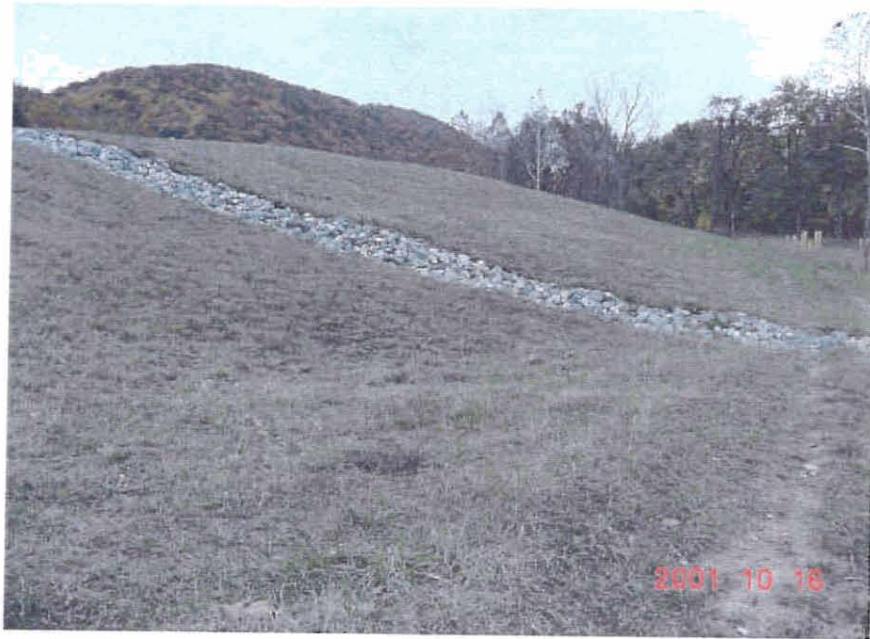
Photograph No.: 9
Date: October 16, 2001

Description: General view showing western edge of the Site 5 landfill.
